## Technical Case Study – Ref 5.1.9

### Growing crops with saline water from a salt pan after installation of a RainBox

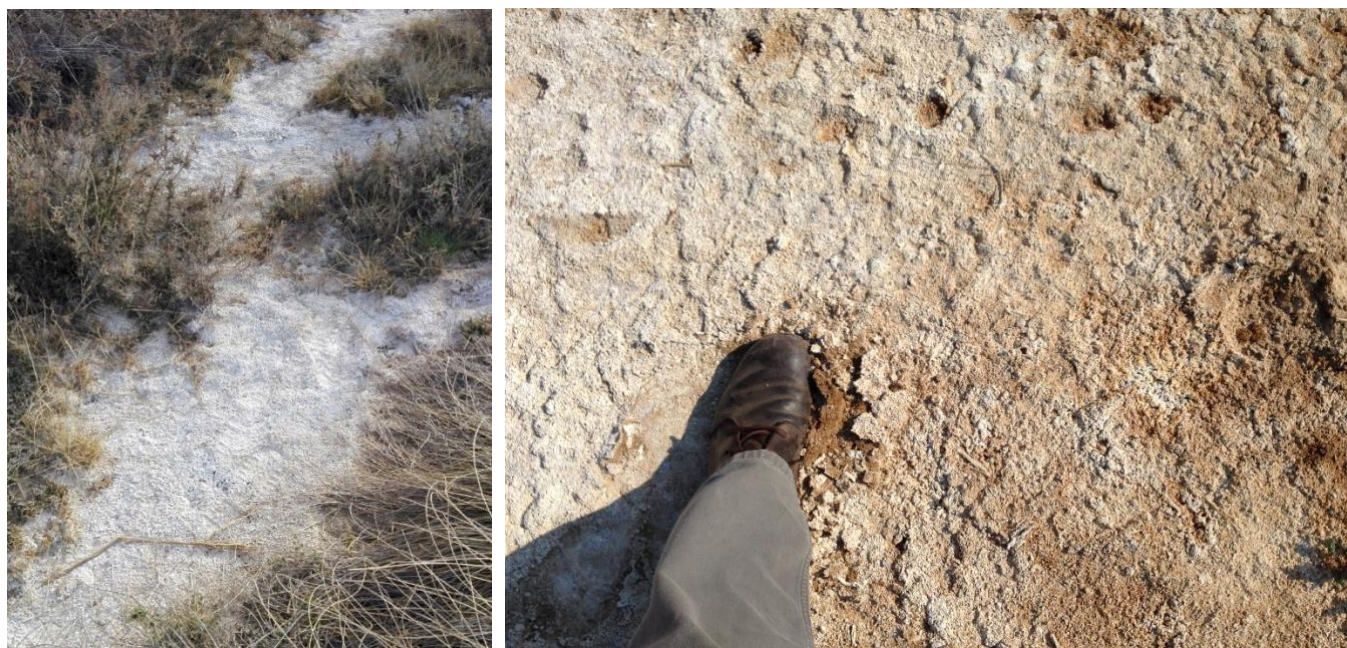
**Salts on the surface of the salt pan around the dam can be seen below:**

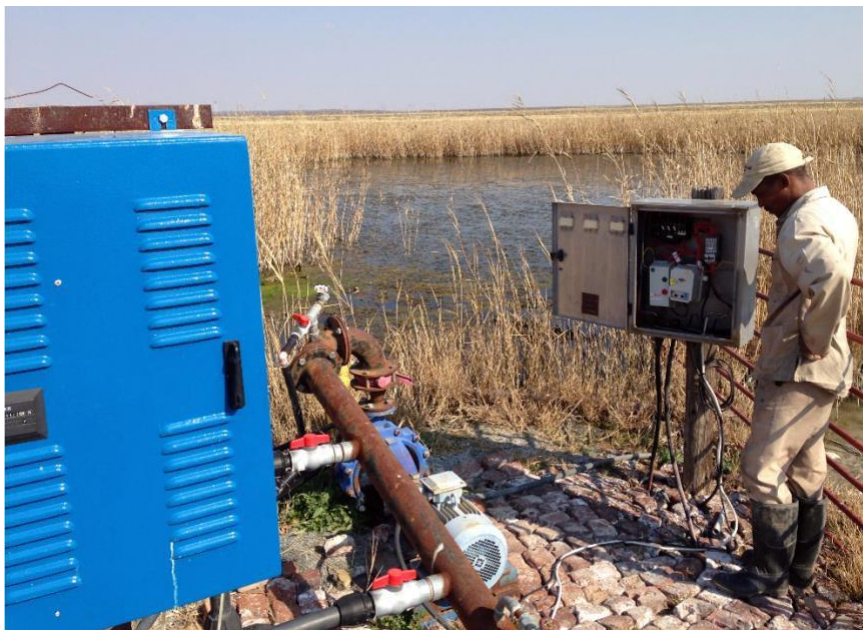
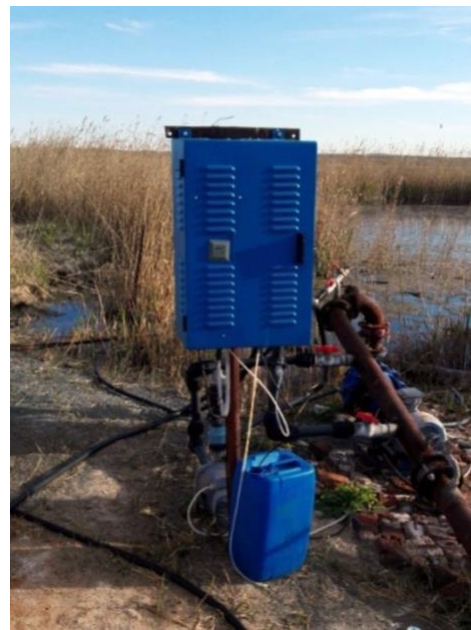
### The RainBox next to the dam:

The lucerne struggled to grow and in early 2012 they decided to install a Agriwater 0.5 Unit on this dam to see if it would be able to optimise the water quality, improve the soils and enable better yields of the lucerne. Within a short while of installation, visible improvements were seen with the lucerne and the soils became loose and aerated once again. Penetrometer readings now reached 30–40 cm, while previously it would not penetrate more than 5–10 cm.

It was also notable that salt build-up and blockages in the pipes and nozzles were eliminated since installation of the RainBox and have never occurred again.
