## Technical Case Study – Ref 5.1.1c

### Comparison of actual irrigation water used by HN Pieterse Farming on lemons, versus standard practice and the Netafim™ uSchedule® software program - 2013 to 2016

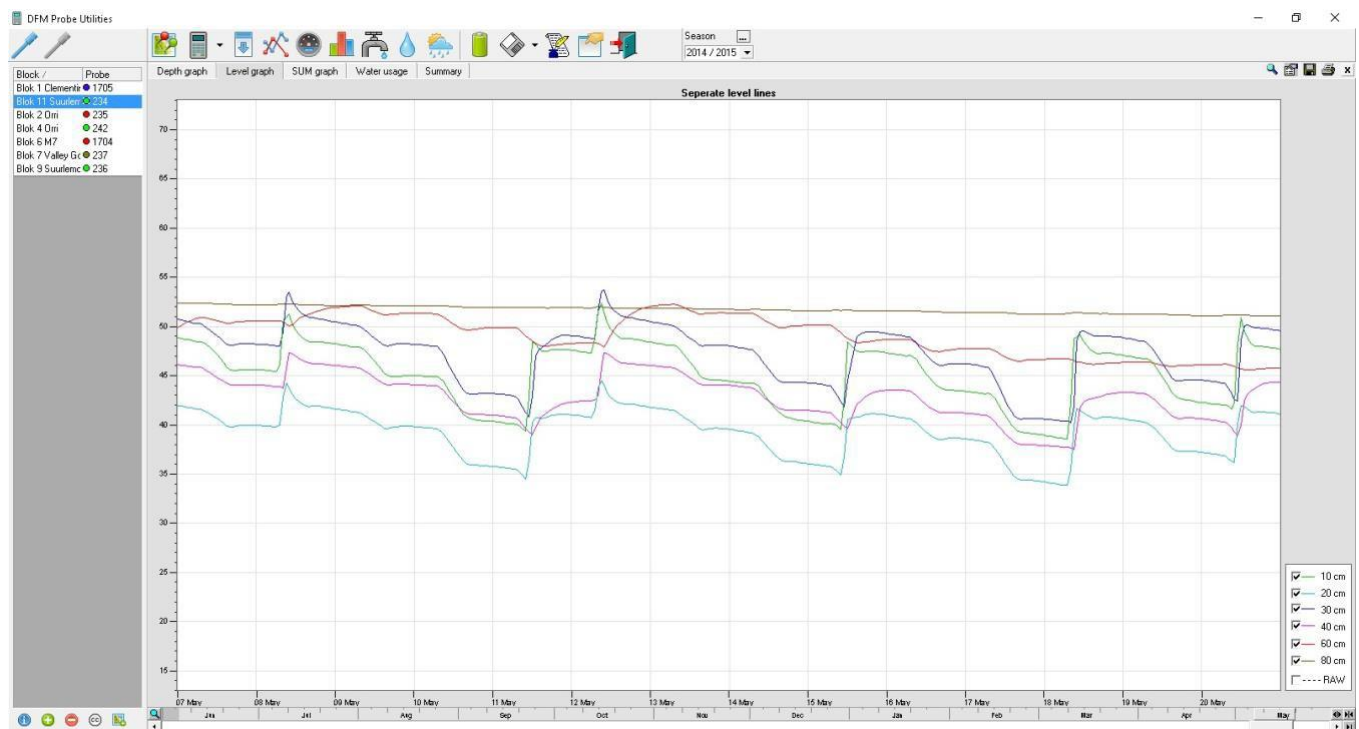
**Figure 2. DFM probe utilities measurements showing water withdrawals at 20, 40 & 60 cm – Block 11 Lemons**

constant monitoring of many profile pits. Shortly after installation of the RainBox, water withdrawals were observed at 20, then 40, then 60 cm as can be clearly seen in Fig. 2 below.

These DFM probe readings for lemons in Block 11 clearly demonstrated the positive effects in soil aeration and water infiltration after installation of the RainBox. Similar readings for all blocks of citrus and grapes on HN Pieterse Farming show exactly the same trend and every pumphouse of HN Pieterse Farming now has RainBox's installed.

To illustrate this standard trend, see Fig. 2 clearly showing the water withdrawals at each measured depth, for the 2014/2015 season on these same lemon orchards. Soils were being aerated, compaction reduced, infiltration improved and water holding capacity improved. Given these observations, the frequency and duration of irrigations were reduced far below that recommended by uSchedule®, or other standard irrigation recommendations.

Previously water withdrawals or “steps” were only visible at 10 and sometimes 20 cm. This meant roots were only really active and drawing water in the day, down to 10-20 cm. Deeper levels had little root activity and the graph level lines >20 cm were straight with no evidence of daily water withdrawals. The soil moisture content only showed the irrigation event as a peak on the graph, which gradually subsided with no steps. When viewed on a daily basis – this was not good at all and indicated poor infiltration, compaction etc.. This was confirmed by
